DEBRIS FLOWS IN KAZANLAK VALLEY, SOUTH SLOPES OF THE BALKAN MOUNTAIN RANGE, BULGARIA

Abstract: Along the Balkan slope of Kazanlak valley there are active debris flows. They are formed in small basins and increase the relief-dissection rate. Their activity is related with deforestation of this area, especially strong during the end of the Medieval period. The fortification of the streams along the south slope of the Balkan Range was a state policy when a Department of Forestation was founded (as department of the National Agency for Torrents Control) in 1904 in Kazanlak town. This research was taken during archeological excavations, when layers stratification around Thracian moulds showed typical alluvial fan gradation. The aim of this study was to characterize the streams, their type, their deposits and their forms of accumulation (using grain size analysis), and to estimate the forestation as prevention activity. The results showed that debris flows in Kazanlak valley are incoherent, the size of their sediment forms is not large but they were fortified very effectively and in present days they are not active.

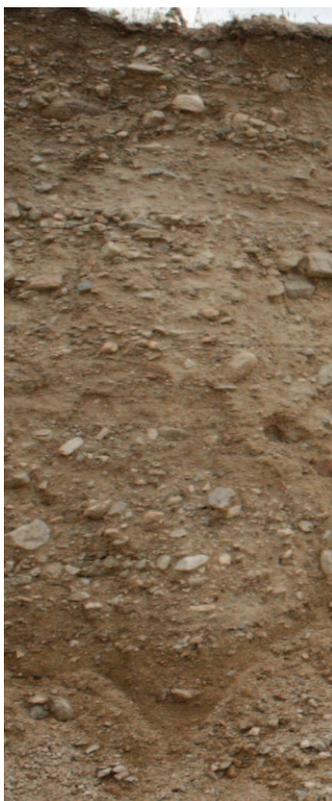
Figure 2. Field description of Profile 1

- 0-36 cm: contemporary soil layer, clayish-sandy with inclusions of subangular gravel. Gravel's long axis is not in one direction;
- 36-175 cm: sandy with larger inclusions;
- 175-202 cm: sandy, lighter and more orange than the upper one, without large inclusions;
- 202–225 cm: sandy, black 2,5Y4/2 - dark grayish brown, with single gravel;
- 225 – 242 cm: sandy, the same as 175-225cm;
- 242 – 280 cm: sandy.

Profile 1 (N42°39'13,7"; E25°27'08,3" - Fig. 2) is in the fan of Novomahalenska River, formed in 1861, in the place where it changed its course to west. There were no sedimentation interruptions along the profile. On Fig. 3 the grain size analysis results are shown.

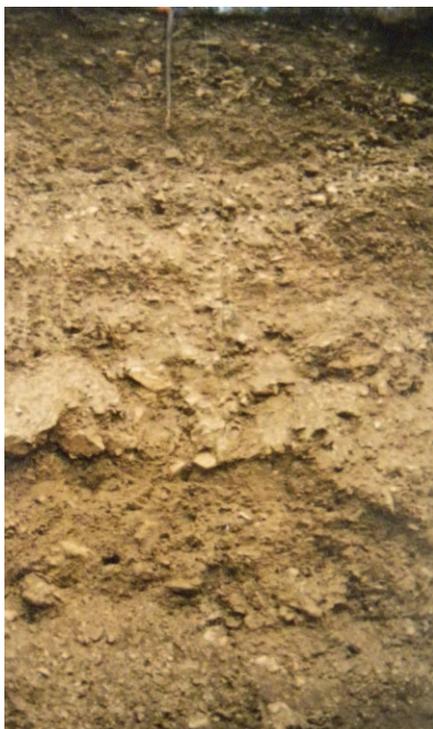
Figure 4. Field description of Profile 2

- 0-60 cm: soil, sandy with subangular gravel and granules;
- 60-130 cm: sandy with more gravel quantity;

- 130 – 420 cm: sandy with more gravel;
- 420-560 cm: sandy with more gravel.

Profile 2 (N42°43'4,7"; E25°19'1,2" - Fig. 4) is located in the west part of Shipka town. This is the upper edge of the mountain foot and the slope inclination is changing from 20 to 12° from north to south towards the Kazanlak valley. We have studied deposits from the alluvial fan of Gratzkoto Dere River. It drains, together with Varovita River, the south slope of the Shipka passage. Here in July-August 1877 were the hardest fights of the Russian-Turkish war. Chronicles are telling about the defense of the passage from the Bulgarian volunteer forces with stones, woods and even dead bodies. Photos from only few years later showed entirely deforested slope.
